**Flood Control Project Maintenance
Levee Inspections**

Maintenance Issue Types Only, Levee Inspection Report By Mile - Spring 2018

Reclamation District No. 0536 Egbert

Waterway	Bank	Unit Miles	Inspection Start/End	Inspector
Unit No. 01 Lindsey Slough	Right	5.58	03/29/2018 03/29/2018	Keith Millard

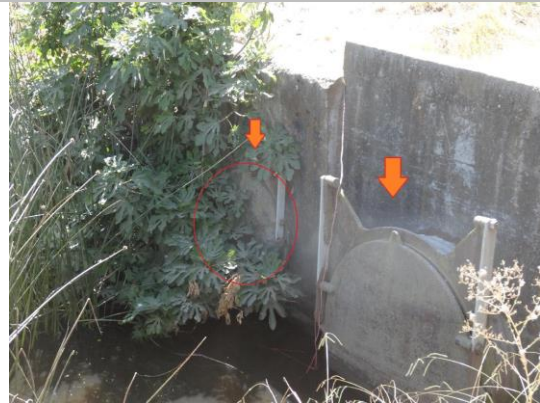
Photo 1 of 3 : UCIP_SP_2018_50161_34457.jpg

FS_ID:50161
DS_ID:22712
EP_NO: 10114
Repair Type: Urgent
Crossing Status: Found
UCIP Comments: 06/01/2016: Holes and heavy corrosion inside pipe on WS have gotten worse. Flapgates appear in good condition though vegetation blocks view of flapgate for 36-inch on WS. These pipes are still in use and necessary for drainage; pipes may be eligible for repair under DWR Deferred Maintenance Program. (K. Fazel - UCIP)08/13/2013:- Holes in pipe outlet due to heavy corrosion.- Needs detailed investigation of the pipe.- Headwall cracked and tilted on WS. (P. Amatya - DWR)
FIELD_STRUCT_DESC: 1 of 2: 60-inch corrugated metal gravity drainage pipe through the levee, 10 feet below the crown. Flap gate on the waterside (WS). Headwall on each end. Culverts run under the road to provide drainage from agricultural fields via a landside (LS) ditch to Lindsey Slough. No. 100 gate in the LS drainage ditch. Reclamation District No. 536 (RD0536) president is David Hearn at hearnd5@gmail.com. (Retention of one 60-inch and one 36-inch drainage pipes through the levee, 10 feet and 6.5 feet below the crown, respectively, and flap gates on the WS ends authorized under Automatic Board Order (ABO) issued as Permit No. 10114, 1974 - H. E. Peterson). [Additional Reference(s): DWR Levee Log, 1992. USACE Sacramento O&M Manual 106, May 1953, (Station 294+49 ""A""), invert elevation 14.4 feet].

WS view: two CMPs with flap gates. Concrete headwall supports the pipes. A 36" CMP (left) and 60" CMP (right).

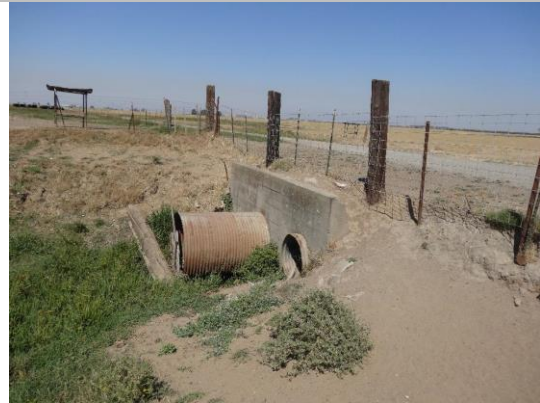
Photo 2 of 3 : UCIP_SP_2018_50161_34456.jpg

LS view: two inlet CMPs with flap gates. Concrete headwall supports the pipes. A 36" CMP (right) and 60" CMP (left).

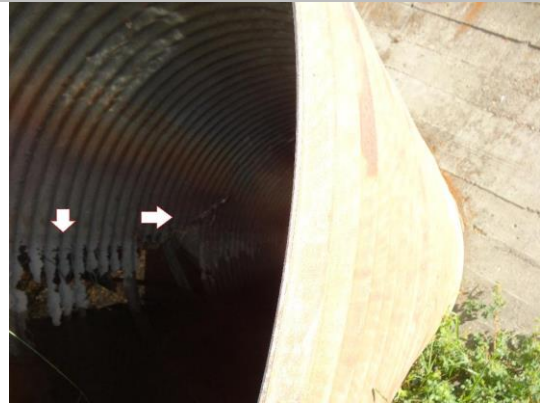
Photo 3 of 3 : UCIP_SP_2018_50161_34455.jpg

FS_ID:50161
DS_ID:22712
EP_NO: 10114
Repair Type: Urgent
Crossing Status: Found
UCIP Comments: 06/01/2016: Holes and heavy corrosion inside pipe on WS have gotten worse. Flapgates appear in good condition though vegetation blocks view of flapgate for 36-inch on WS. These pipes are still in use and necessary for drainage; pipes may be eligible for repair under DWR Deferred Maintenance Program. (K. Fazel - UCIP)08/13/2013:- Holes in pipe outlet due to heavy corrosion.- Needs detailed investigation of the pipe.- Headwall cracked and tilted on WS. (P. Amatya - DWR)
FIELD_STRUCT_DESC: 1 of 2: 60-inch corrugated metal gravity drainage pipe through the levee, 10 feet below the crown. Flap gate on the waterside (WS). Headwall on each end. Culverts run under the road to provide drainage from agricultural fields via a landside (LS) ditch to Lindsey Slough. No. 100 gate in the LS drainage ditch. Reclamation District No. 536 (RD0536) president is David Hearn at hearnd5@gmail.com. (Retention of one 60-inch and one 36-inch drainage pipes through the levee, 10 feet and 6.5 feet below the crown, respectively, and flap gates on the WS ends authorized under Automatic Board Order (ABO) issued as Permit No. 10114, 1974 - H. E. Peterson). [Additional Reference(s): DWR Levee Log, 1992. USACE Sacramento O&M Manual 106, May 1953, (Station 294+49 ""A""), invert elevation 14.4 feet].

LS view: holes & cracks on CM pipe due to heavy corrosion. Needs detailed investigation of the pipe.

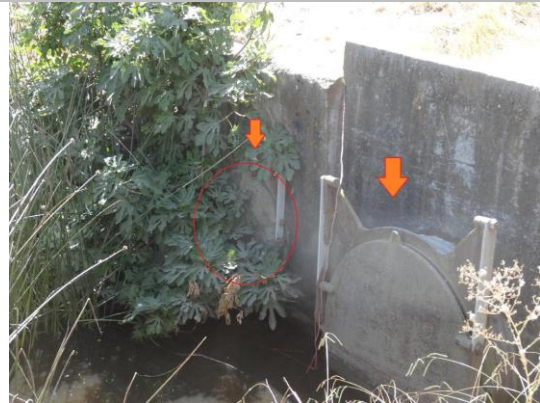
Photo 1 of 3 : UCIP_SP_2018_50160_34771.jpg

FS_ID:50160
DS_ID:22726
EP_NO: 10114
Repair Type: Urgent
Crossing Status: Found
UCIP Comments: 06/01/2016 Pipe is not abandoned. Though neglected, it is still functional and a needed system feature. Pipe is severely corroded with holes in it, which are visible on LS. Vegetation blocks view of flapgate on WS. Pipes may be eligible for repair under DWR Deferred Maintenance Program. (K. Fazel - UCIP)08/13/2013 This pipe seems to be abandoned. Headwall cracked and tilted on WS. (P. Amatya)
FIELD_STRUCT_DESC: 2 of 2: 36-inch corrugated metal gravity drainage pipe through the levee, 10 feet below the crown. Flap gate on the waterside (WS). Headwall on each end. Culverts run under the road to provide drainage from agricultural fields via a landside (LS) ditch to Lindsey Slough. No. 100 gate in the LS drainage ditch. Reclamation District No. 536 (RD0536) president is David Hearn at hearnd5@gmail.com. (Retention of one 60-inch and one 36-inch drainage pipes through the levee, 10 feet and 6.5 feet below the crown, respectively, and flap gates on the WS ends authorized under Automatic Board Order (ABO) issued as Permit No. 10114, 1974 - H. E. Peterson). [Additional Reference(s): DWR Levee Log, 1992, referenced as 6.5 feet below the crown. USACE Sacramento O&M Manual 106, May 1953, (Station 294+49 "A"), invert elevation 14.4 feet].

WS view: concrete headwall, flap gates on 36" CMP (left) and 60" CMP (right)

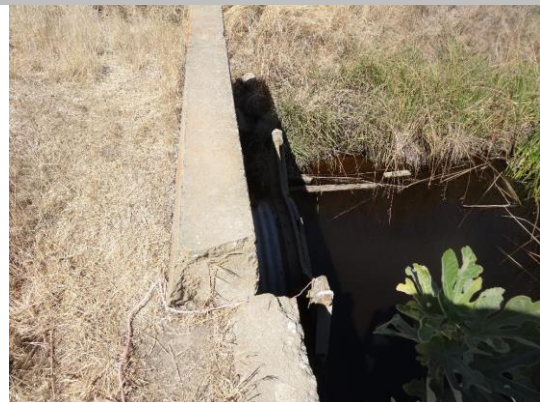
Photo 2 of 3 : UCIP_SP_2018_50160_34770.jpg

WS view: cracked and tilted concrete headwall.

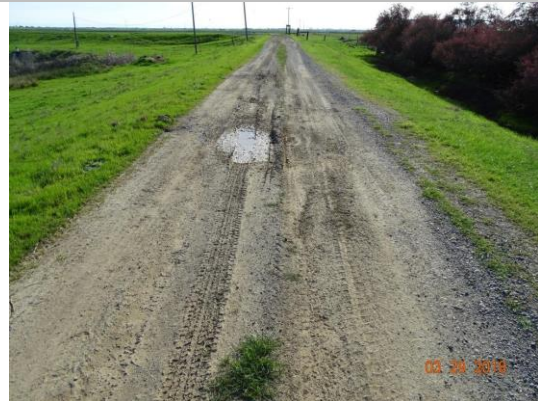
Photo 1 of 1 : SP_2018_RD0536_208_21_20180329_00060.jpg

LM Start	0.28	Rating **	M	Issue No.	21
LM End	0.37	Issue Type +	Ma	Location *	CR
Category	Earthen Levee			GPS Latitude/Longitude	
				Start	End
Item	Crown Surface / Depressions / Rutting			38.245602 °	38.245713 °
				-121.764047 °	-121.762449 °
DWR ID	DWR_RD0536_01_s_2017_21				
Comment Code					
C2 : Repair depressions or ruts in the crown or slope.					
Inspector Comment					
Crown rutting has been reduced by regrading and addition of base rock in RD536, but still exists in this area. Should be repaired.

Crown should be graded and surfaced with base rock.

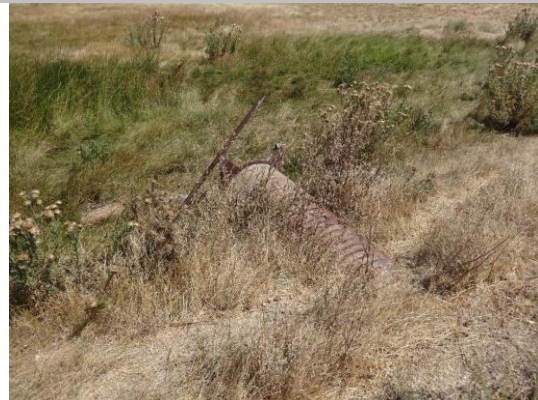
Photo 1 of 3 : UCIP_SP_2018_49313_34774.jpg

Comment Code						
Inspector Comment						
FS_ID:49313 DS_ID:22713 EP_NO: 10114 Repair Type: No Action Needed Crossing Status: Found UCIP Comments: 06/01/2016 Debris cleared and flapgate is no longer blocked. 08/13/2013 Outlet was blocked by concrete debris and dirt.Needs cleaning of debris. FIELD_STRUCT_DESC: 24-inch corrugated metal gravity drainage pipe through the levee, 10.5 feet below the crown. Flap gate on the waterside (WS) end. Headwall on each end, not found in 2013 or 2016. No. 100 gate on the WS. Concrete debris on the WS slope. This crossing is also used for irrigation. 1-inch polyvinyl chloride (PVC) pipe sleeved through the 24-inch pipe, visible through the landside (LS) end. According to David Hearn, Reclamation District No. 536 (RD0536) president, the PVC pipe does not connect all the way through. Present landowner, as of 2016, is Solano Land Trust, and the pipe runs through the Jepson Prairie Reserve, managed by the University of California, Davis, (UC Davis). (Retention of a 24-inch drainage pipe through the levee, 10.5 feet below the crown, and a flap gate on the WS end authorized under Automatic Board Order (ABO) issued as Permit No. 10114, 1974 - H. E. Peterson). [Additional Reference(s): DWR Levee Log, 1992. USACE Sacramento O&M Manual 106, May 1953, (Station 274+00 ""A""), invert elevation 15.8 feet]. FS Date: 6/1/2016

WS view: overview of exposed CM pipe on levee slope.

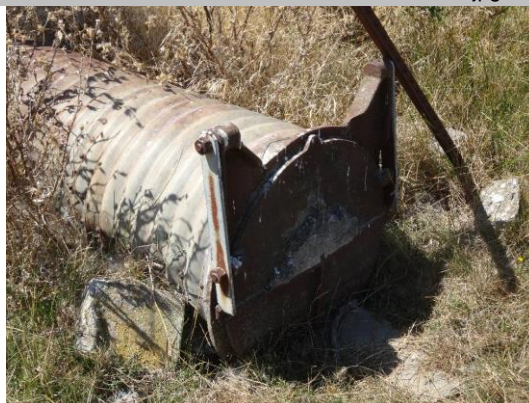
Photo 2 of 3 : UCIP_SP_2018_49313_34773.jpg

FS_ID:49313
DS_ID:22713
EP_NO: 10114
Repair Type: No Action Needed
Crossing Status: Found
UCIP Comments: 06/01/2016 Debris cleared and flapgate is no longer blocked. 08/13/2013 Outlet was blocked by concrete debris and dirt. Needs cleaning of debris.
FIELD_STRUCT_DESC: 24-inch corrugated metal gravity drainage pipe through the levee, 10.5 feet below the crown. Flap gate on the waterside (WS) end. Headwall on each end, not found in 2013 or 2016. No. 100 gate on the WS. Concrete debris on the WS slope. This crossing is also used for irrigation. 1-inch polyvinyl chloride (PVC) pipe sleeved through the 24-inch pipe, visible through the landside (LS) end. According to David Hearn, Reclamation District No. 536 (RD0536) president, the PVC pipe does not connect all the way through. Present landowner, as of 2016, is Solano Land Trust, and the pipe runs through the Jepson Prairie Reserve, managed by the University of California, Davis, (UC Davis). (Retention of a 24-inch drainage pipe through the levee, 10.5 feet below the crown, and a flap gate on the WS end authorized under Automatic Board Order (ABO) issued as Permit No. 10114, 1974 - H. E. Peterson). [Additional Reference(s): DWR Levee Log, 1992. USACE Sacramento O&M Manual 106, May 1953, (Station 274+00 "'A'"), invert elevation 15.8 feet].

WS view: CM pipe blocked by concrete debris on levee slope.

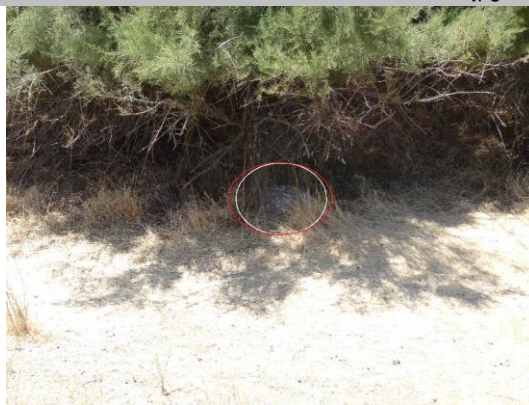
Photo 3 of 3 : UCIP_SP_2018_49313_34772.jpg

LS view: open CM pipe end on levee slope.

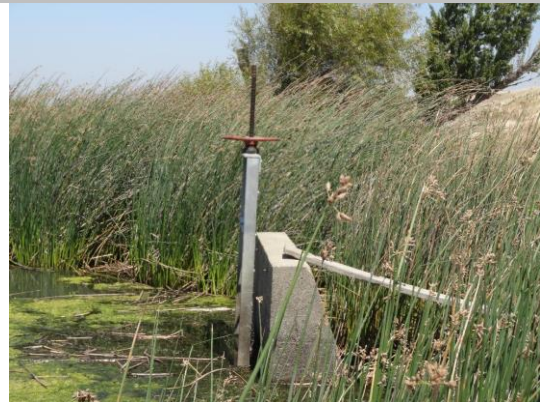
Photo 1 of 2 : UCIP_SP_2018_20444_34493.jpg

Comment Code						
Inspector Comment						
FS_ID:20444 DS_ID:22715 EP_NO: 10115 Repair Type: No Action Needed Crossing Status: Found UCIP Comments: Pipe was submerged into water and not visible.Steel bar fence on both sides of the levee. FIELD_STRUCT_DESC: 42-inch corrugated metal gravity drainage pipe through the levee, 22.5 feet below the crown. Concrete headwall on each end. Screw gate on the waterside (WS) end. (Retention of a 42-inch drainage pipe through the levee, 22.5 feet below the crown, and a slide gate on the WS end authorized under Automatic Board Order (ABO) issued as Permit No. 10115, 1974 - Petersen Estate Company, care of R. Moss). [Additional Reference(s): DWR Levee Log, 1992. USACE Sacramento O&M Manual 106, May 1953, (Station 238+36 ""A""), invert elevation 1.5 feet]. FS Date: 8/13/2013

WS view: slide gate, concrete headwall in the channel. Pipe submerged into water.

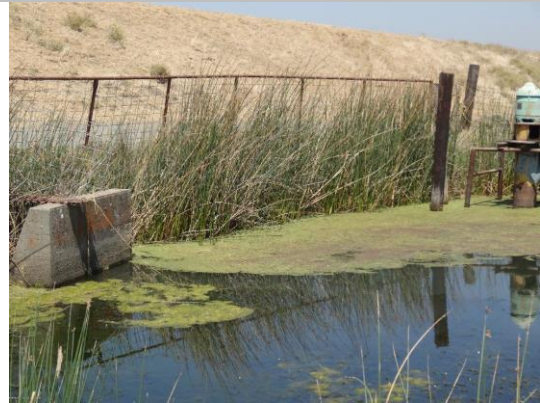
Photo 2 of 2 : UCIP_SP_2018_20444_34492.jpg

LS view: concrete headwall in the channel/irrigation ditch. Pipe submerged into water.

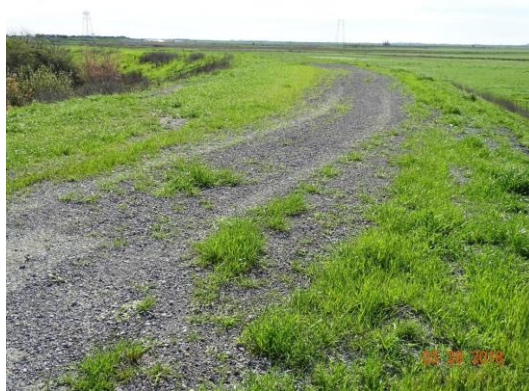
Photo 1 of 1 : SP_2018_RD0536_208_56_20180329_00061.jpg

LM Start	2.69	Rating **	A/W	Issue No.	56
LM End	2.71	Issue Type +	Ma	Location *	CR
Category	Earthen Levee			GPS Latitude/Longitude	
				Start	End
Item	Crown Surface / Depressions / Rutting			38.255197 °	38.254973 °
				-121.737932 °	-121.737577 °
DWR ID	DWR_RD0536_01_f_2014_56				
Comment Code					
C2 : Repair depressions or ruts in the crown or slope.					
Inspector Comment					
Possible subsidence in this area has been repaired. Grade was restored and base rock was added to crown. Area looks good on 3/29/18. Should continue to monitor this site for possible future subsidence.

3/29/2018: Crown rutting and possible subsidence has been repaired, but area should continue to be monitored for possible future subsidence.

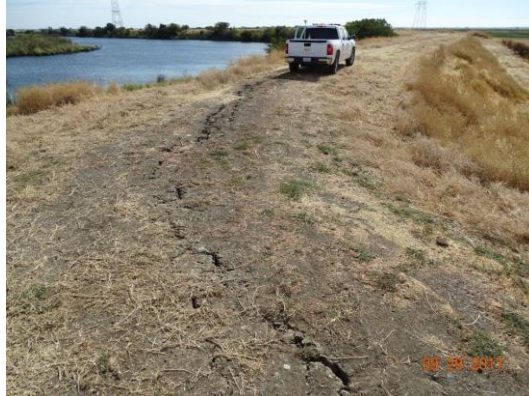
Photo 1 of 1 : SP_2018_RD0536_208_18_20180305_00004.jpg

LM Start	2.95	Rating **	A/W	Issue No.	18
LM End	2.95	Issue Type +	Ma	Location *	CR
Category	Earthen Levee			GPS Latitude/Longitude	
				Start	End
Item	Cracking			38.256047 °	38.256047 °
				-121.733728 °	-121.733728 °
DWR ID	DWR_RD0536_01_f_2017_18				
Comment Code					
CR1 : Monitor and have inspected by geotechnical engineer.					
Inspector Comment					
9/29/2017: Cracks in and along crown. Possible indicator of land side slumping. Cracks up to 6 inches wide and 2 feet deep. 3/29/2018: Crown has been graded and base rock added. No cracks visible. Area should continue to be monitored for future cracking.

09/29/2017: Cracks in crown.

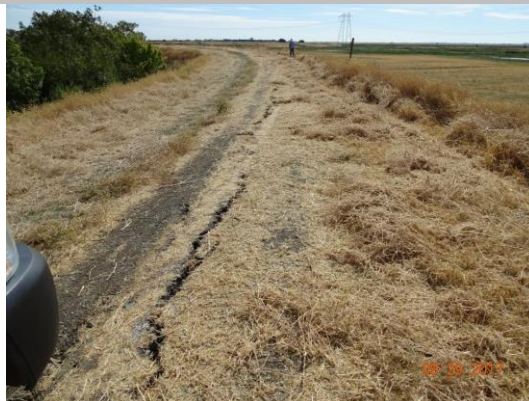
Photo 1 of 1 : SP_2018_RD0536_208_19_20180305_00006.jpg

LM Start	2.99	Rating **	A/W	Issue No.	19
LM End	3.00	Issue Type +	Ma	Location *	LS
Category	Earthen Levee			GPS Latitude/Longitude	
				Start	End
Item	Cracking			38.255581 °	38.255562 °
				-121.733117 °	-121.733085 °
DWR ID	DWR_RD0536_01_f_2017_19				
Comment Code					
CR2 : Schedule repair of subsidence prior to the next inspection.					
Inspector Comment					
9/29/2017: Cracking on crown indicating slumping on land side. Crack width up to 8 inches, vertical drop on land side 3 to 5 inches, depth up to 2 feet. 3/29/2018: Crown has been graded and base rock added. No cracks visible. Area should continue to be monitored for future cracking.

09/29/2017: Cracks in crown showing vertical offset with land side lower than most of crown.

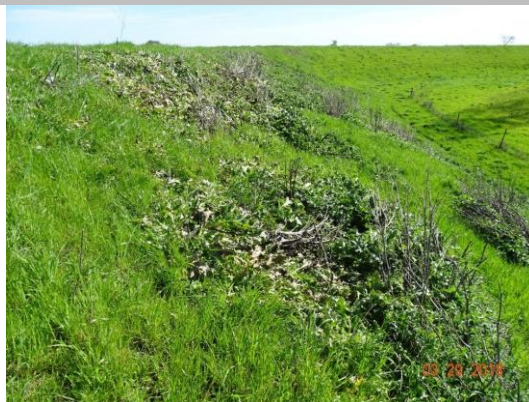
Photo 1 of 1 : SP_2018_RD0536_208_27_20180329_00062.jpg

LM Start	3.26	Rating **	M	Issue No.	27
LM End	3.32	Issue Type +	Ma	Location *	LS
Category	Earthen Levee			GPS Latitude/Longitude	
				Start	End
Item	Vegetation			38.256407 °	38.256839 °
				-121.728683 °	-121.727673 °
DWR ID	DWR_RD0536_01_s_2018_27				
Comment Code					
V1 : Control annual grass and weeds on the levee slopes and easements.					
Inspector Comment					
Control growth of broadleaf vegetation on landside slope. This veg quickly hides features that may be of concern.

Broad leaf veg hides slope; should be removed/managed.

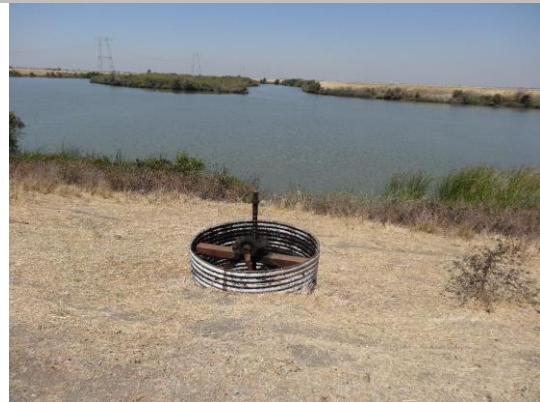
Photo 1 of 3 : UCIP_SP_2018_20503_34568.jpg

Comment Code						
Inspector Comment						
FS_ID:20503 DS_ID:22718 EP_NO: 10116 Repair Type: No Action Needed Crossing Status: Found UCIP Comments: Vortex seen on WS. Water flow seen on LS.Saddle, apron, and headwall not visible. Inlet and outlet pipe-ends are submerged into water. FIELD_STRUCT_DESC: 54-inch corrugated metal gravity drainage pipe through the levee, 30 feet below the crown. Screw gate in a pipe riser on the waterside (WS) slope. Saddle, apron, headwall, two corrugated metal cutoff walls, one No. 101 gate, and one No. 102 gate. (Retention of a 54-inch drainage pipe through the levee, 30 feet below the crown, and a slide gate on the WS slope authorized under Automatic Board Order (ABO) 10116, 1974 - Marion Sanchez Farms). [Additional Reference(s): DWR Levee Log, 1992. USACE Sacramento O&M Manual 106, May 1953, (Station 87+70 ""R""), invert elevation -2 feet]. FS Date: 8/13/2013

WS view: CMP riser with slide gate on levee slope. Water channel on background.

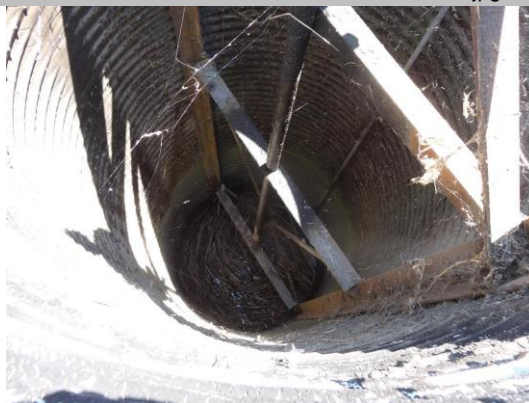
Photo 2 of 3 : UCIP_SP_2018_20503_34567.jpg

WS view: closer view of slide gate in CMP riser on levee slope.

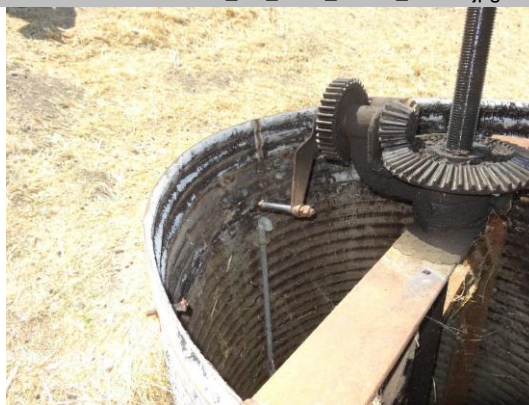
Photo 3 of 3 : UCIP_SP_2018_20503_34566.jpg

WS view: closer view of slide gate in CMP riser on levee slope. Air vent attached to the wall of CMP (left).

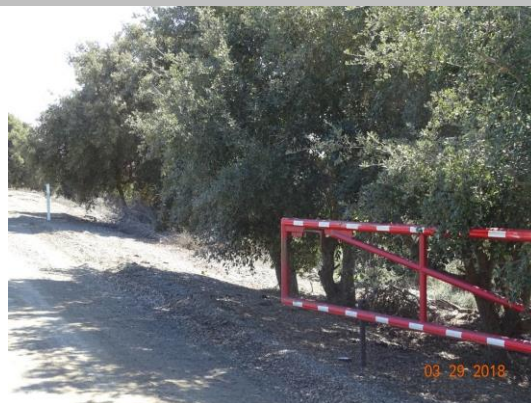
Photo 1 of 2 : SP_2018_RD0536_208_65_20180329_00064.jpg

LM Start	5.17	Rating **	U	Issue No.	65
LM End	5.39	Issue Type +	Ma	Location *	LS
Category	Earthen Levee			GPS Latitude/Longitude	
				Start	End
Item	Trim / Thin Trees			38.245300 °	38.245742 °
				-121.704909 °	-121.700893 °
DWR ID	DWR_RD0536_01_s_2014_65				
Comment Code					
T1 : Trim trees to at least five feet above ground level.					
Inspector Comment					
Very small oak and olive trees on lower slope should be removed from the landward slope and shoulder before they get any larger. Larger trees should be trimmed up to 5 feet above levee slope to allow inspection and access.

Large oak and olive trees should be trimmed to at least 5 feet above slope to allow inspection and access.

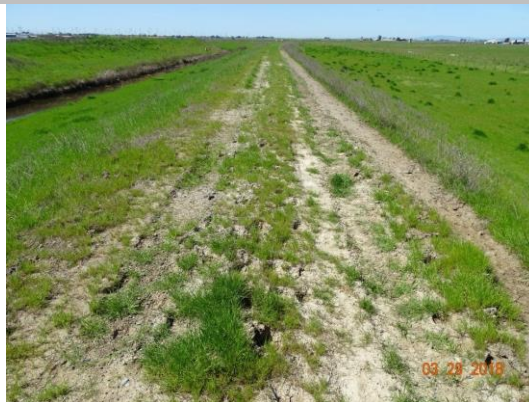
Photo 1 of 1 : SP_2018_RD0536_209_21_20180329_00015.jpg

LM Start	3.91	Rating **	M	Issue No.	21
LM End	3.91	Issue Type +	Ma	Location *	CR
Category	Earthen Levee			GPS Latitude/Longitude	
				Start	End
Item	Crown Surface / Depressions / Rutting			38.196745 °	38.196745 °
				-121.691292 °	-121.691292 °
DWR ID	DWR_RD0536_02_s_2018_21				
Comment Code					
C2 : Repair depressions or ruts in the crown or slope.					
Inspector Comment

Crown should be graded and surfaced with base rock.
